METAL 2013 EDINBURGH, SCOTLAND

Conference Proceedings

'SAFE OR NOT?' A PROACTIVE APPROACH TO LOOK AFTER AN AIRCRAFT DISPLAY AT THE HONG KONG SCIENCE MUSEUM

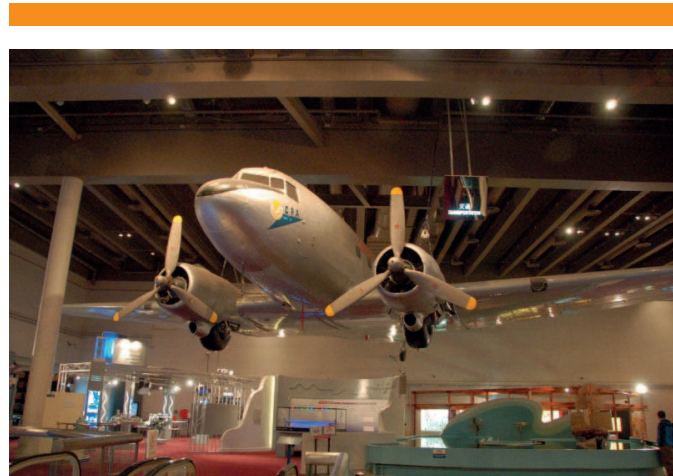
Figure 1: Suspending DC-3 *Betsy* from the ceiling of the Hong Kong Science Museum.

- Three steel eye-rings were installed onto the structural members of the building as ceiling anchors to take the dead weight of *Betsy* and all dynamic loads imposed to the object from the environment;
- Structural fittings located at the nacelles and empennage, which were pre-designed to lift the aircraft for regular maintenance work in a hangar during her service life, were selected as the suspension points of *Betsy*. The attachment mechanism of each hoisting point was carefully designed to make sure that such suspension could be done on permanent basis without any damage to the aircraft structure (see Fig. 1).

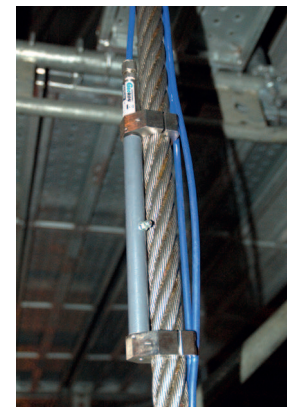
Figure 3: Vibrating wire strand-meter on sling wire.

Eight sets of vibrating wire strand-meters were installed onto all of the sling wires suspending *Betsy* (Fig. 3). Any deformation on wire strands will affect the tension of the wire and the actual degree of change can be determined accurately by measuring the change of strain (see Fig. 4 for the locations of all the strand-meters (i.e. WL01-03, WR01-03 and WT01-02)).

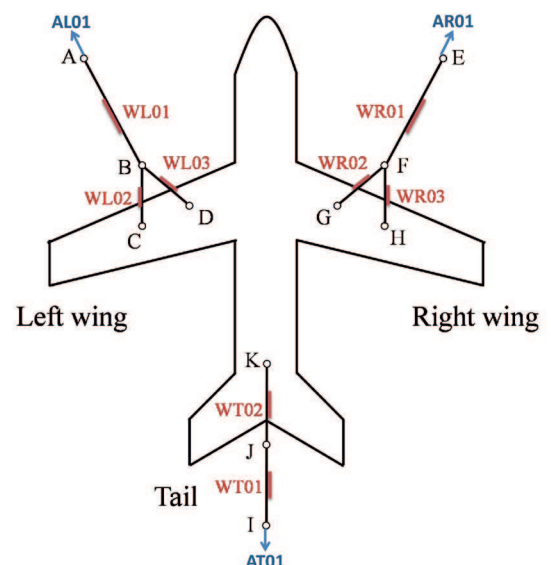
Figure 4: Location of all monitoring sensors for *Betsy*.

Three sets of resistance strain gauges were deployed for checking the integrity of the steel ceiling anchors (Fig. 5). Physical deformation of these structures can be determined through the change of electrical resistance detected by the sensors attached to the anchors. AL01, AR01 and AT01 in Fig. 6 represent the locations of the resistance strain gauges.

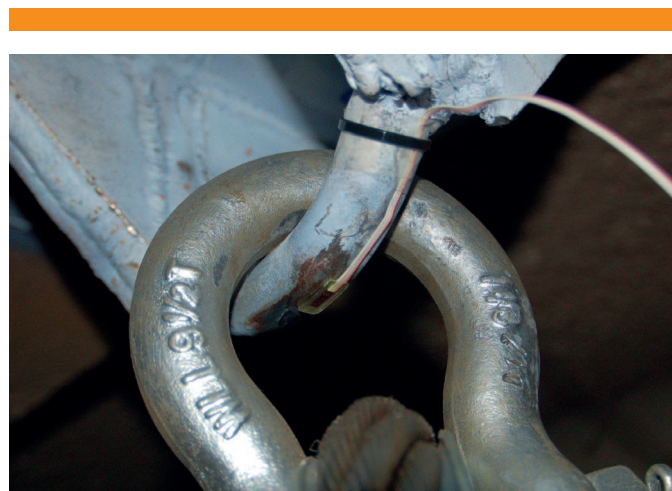
Figure 5: Resistance strain gauge, model FLA-3-11-3LT, on ceiling anchor.

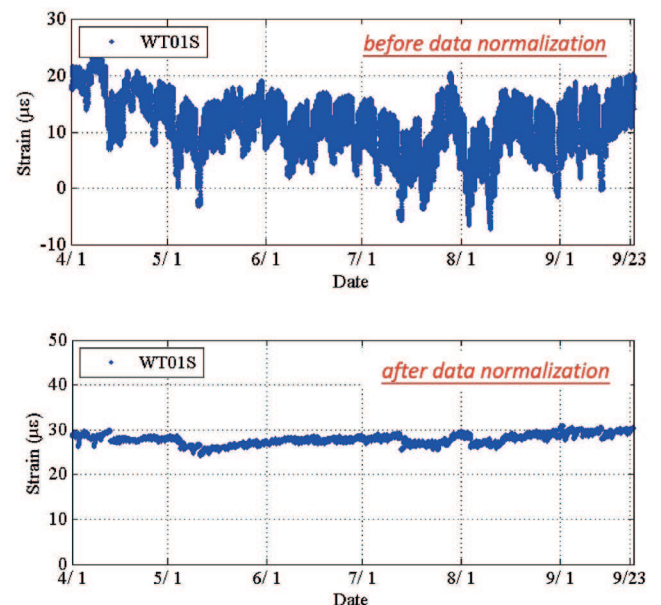
Figure 7: Strain readings of sensor WT01 (i.e. sling wire IJ) before and after data normalisation.

Over the last two years, since the commencement of the SHM programme in January 2011, it was observed that the strain readings would vary with temperature of the ambient environment giving rise to a temperature variation pattern (Fig. 6). Such patterns in fact follow the material properties such that, under a static mode of display with minimal dynamic loading introduced by the structure, strain reading decreases when temperature increases. In order to isolate those strain values responding to temperature variation, a data normalisation process was conducted so as to identify the change of strain due to the actual deformation of sling wires. Figure 7 illustrates the strain readings of sensor WT01 (i.e. sling wire IJ) before and after data normalisation.
