The Rebirth of the Door Gods: Conservation of a Pair of Traditional Chinese Timber Entrance Doors

Eddy S T Leung, Kit Wong, Alice Tsang
Conservation Office, Leisure and Cultural Services Department, HKSARG

ICOM-CC
TRIENNIAL CONFERENCE
2012

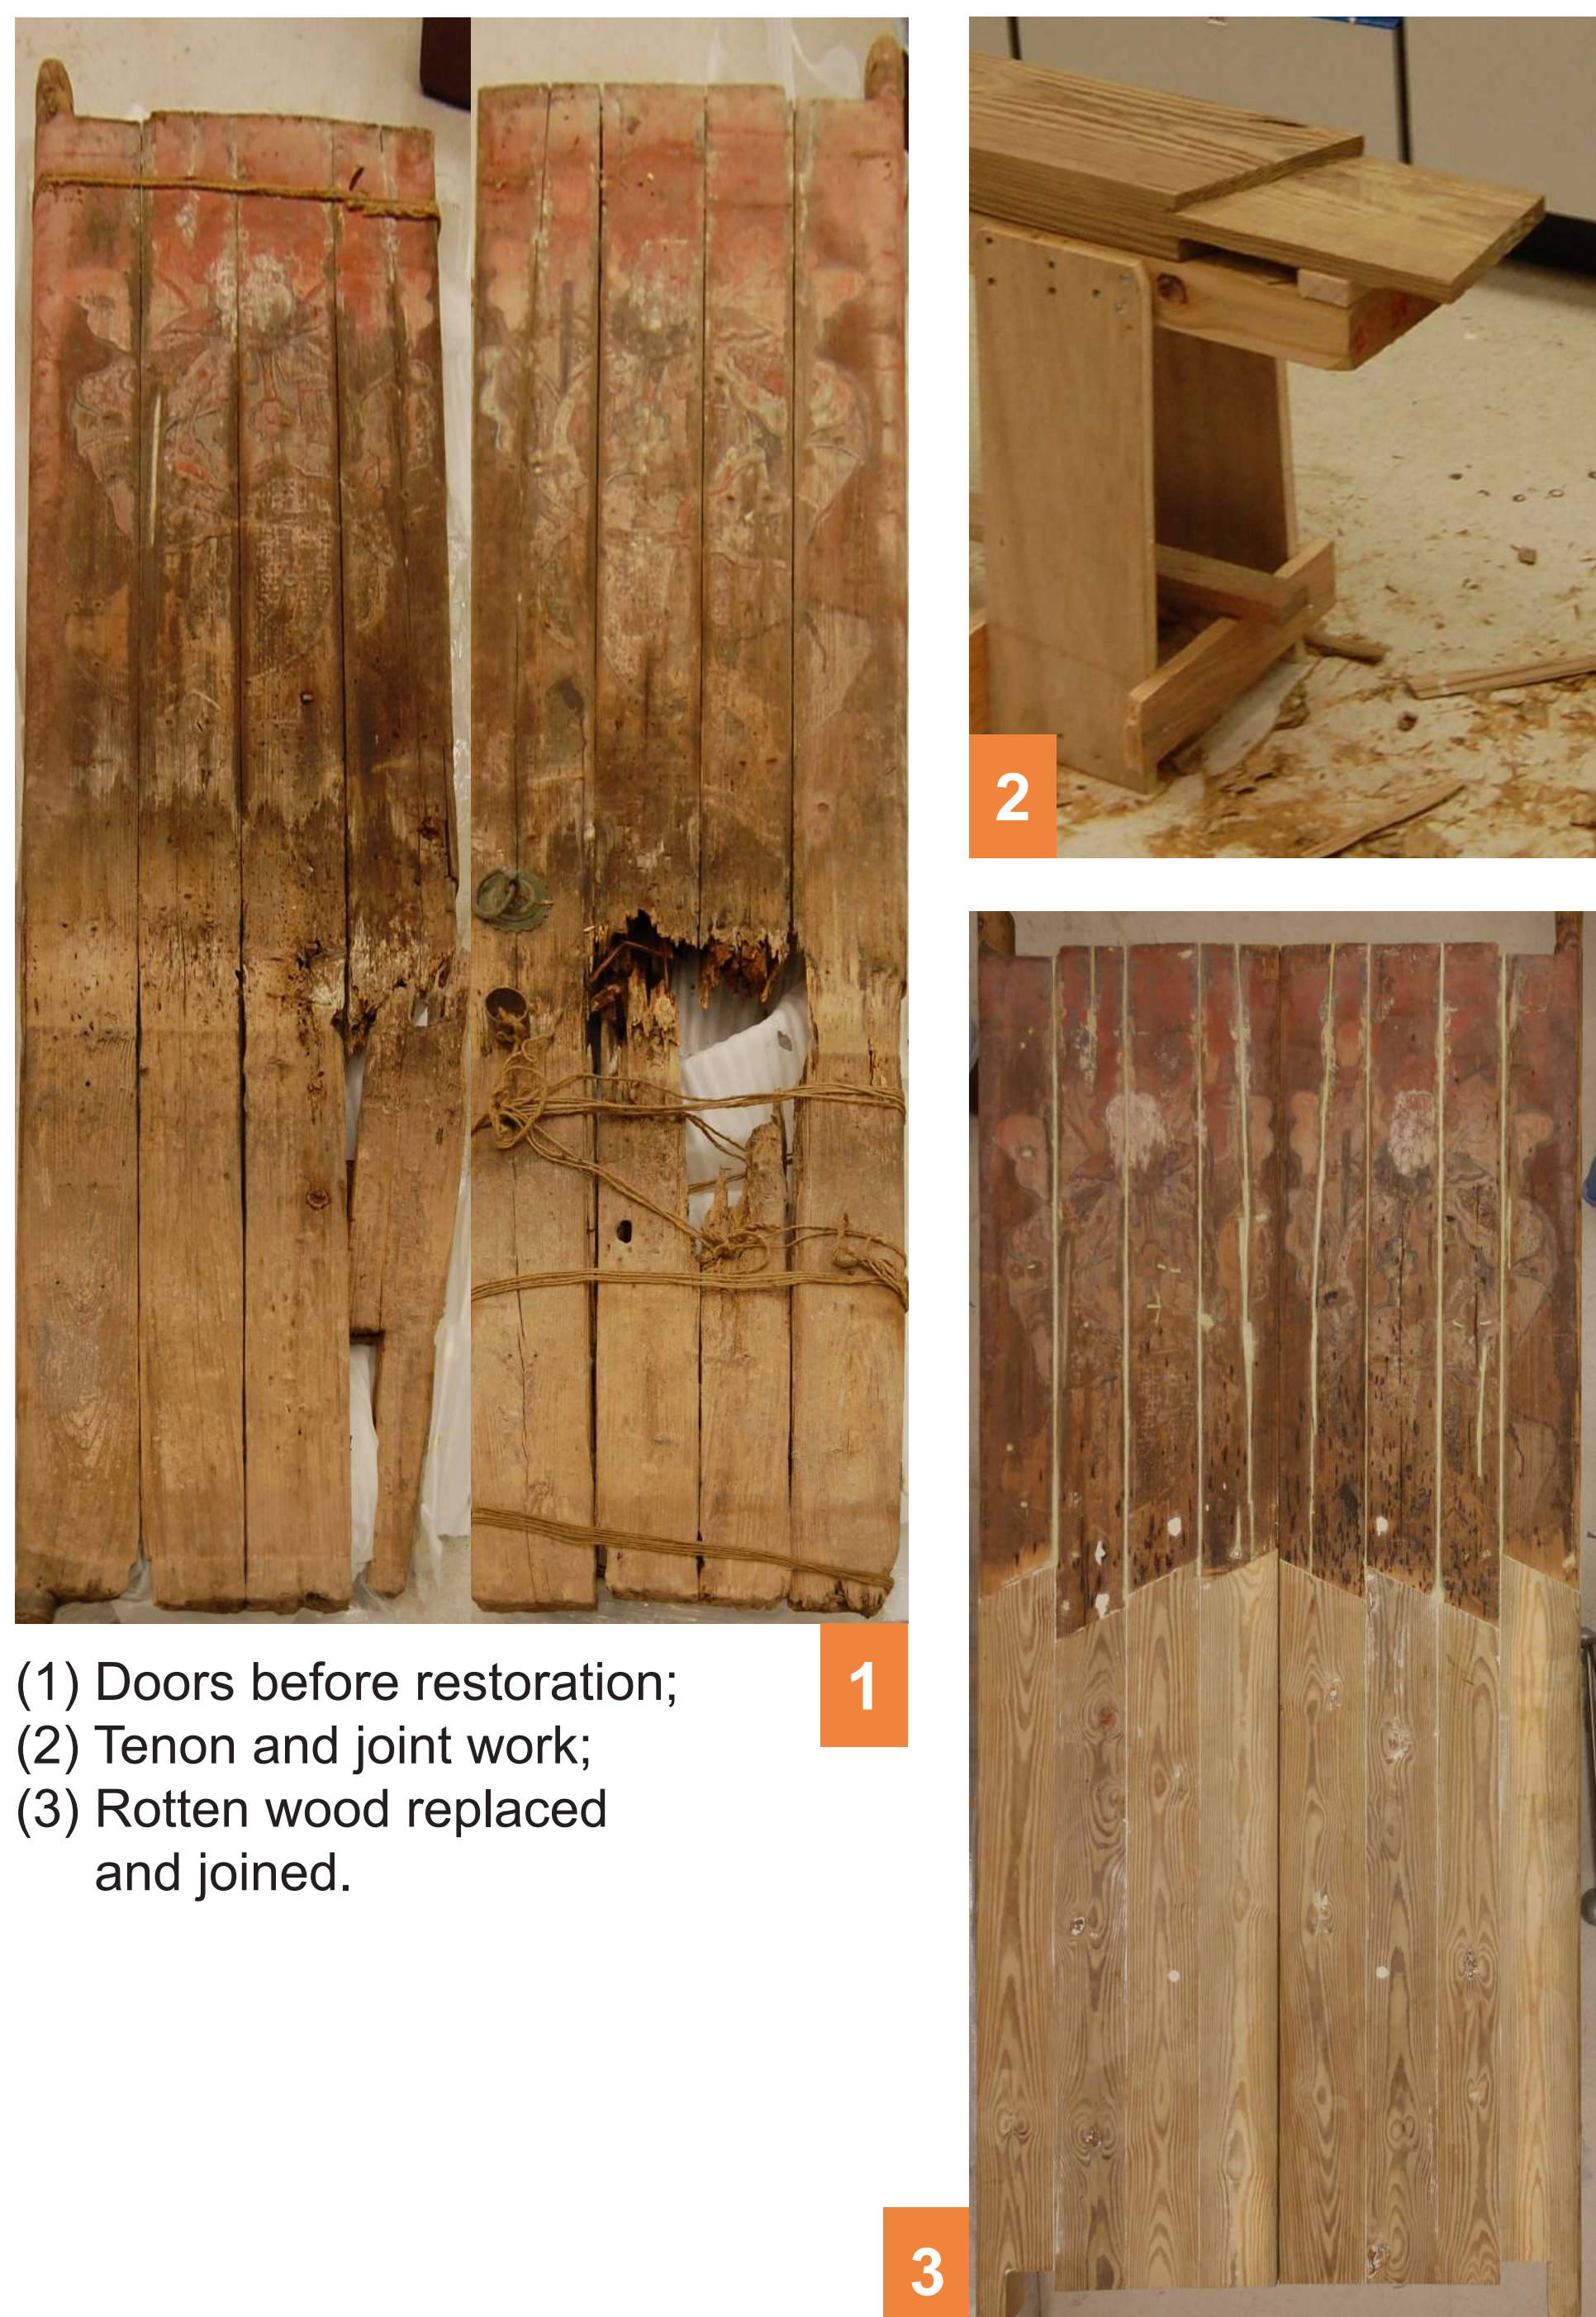
(1) Doors before restoration;
(2) Tenon and joint work;
(3) Rotten wood replaced
and joined.

The timber doors were partly rotten at the bottom, losing much of their structural strength, and the two door gods were severely faded. Striking a balance between preservation of the doors' physical originality to retain their cultural significance and their functionality after restoration, conservators first determined whether wood sections could be retained or should be replaced. Wood analysis was carried out to identify the original wood species, so that the same kind of wood could be used for replacement to attain a similar expansion and contraction coefficient between the original and the replaced parts. Tenon and joint, along with bamboo nails, were used to connect the original and replaced sections.

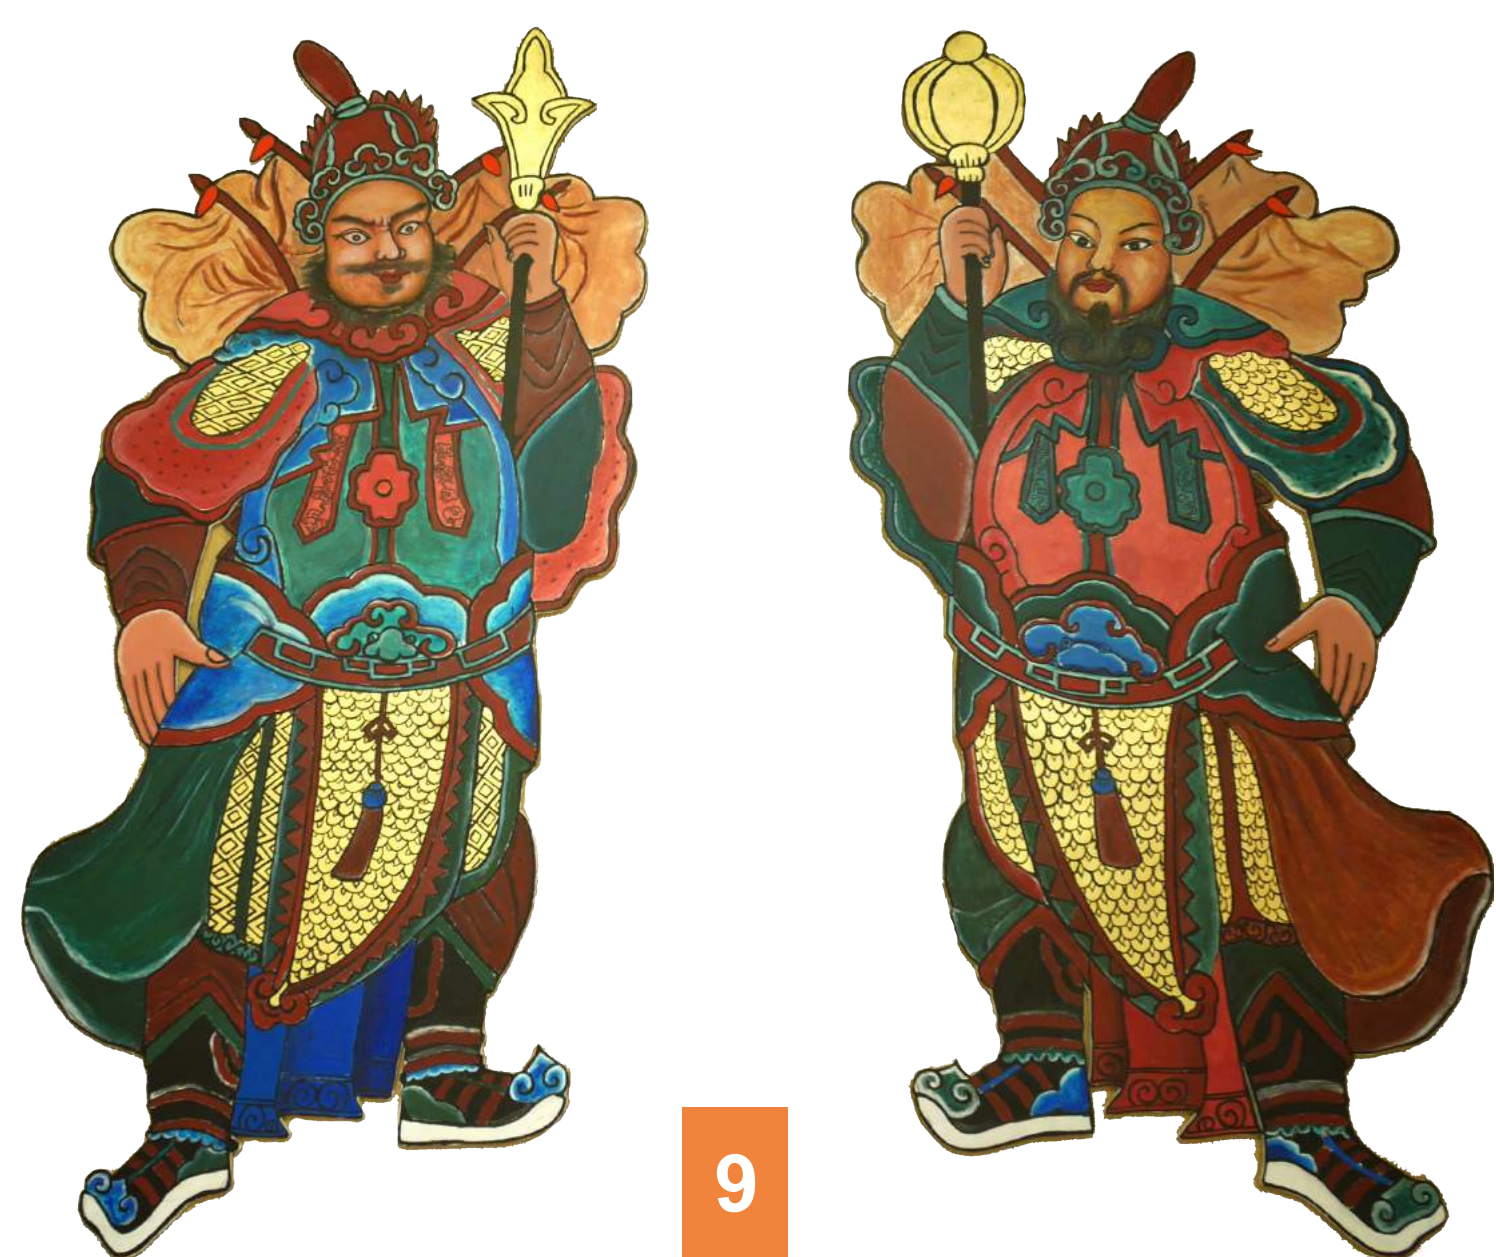
9

(4) Image before restoration;
(5) Infrared imaging;
(6) 3D laser scanning;
(7) Scanned image;
(8) Image traced;
(9) First draft of door gods.

The doors were first examined under infrared imaging to check for underlying drawings, to no avail. To enhance the faded carved lines for the purpose of recapturing the image of the door gods, 3D laser scanning was carried out. The original look of the door gods became more noticeable as a scanned image. Conservators used these carved details and the remaining patterns to trace and draft the door gods back onto the wood.

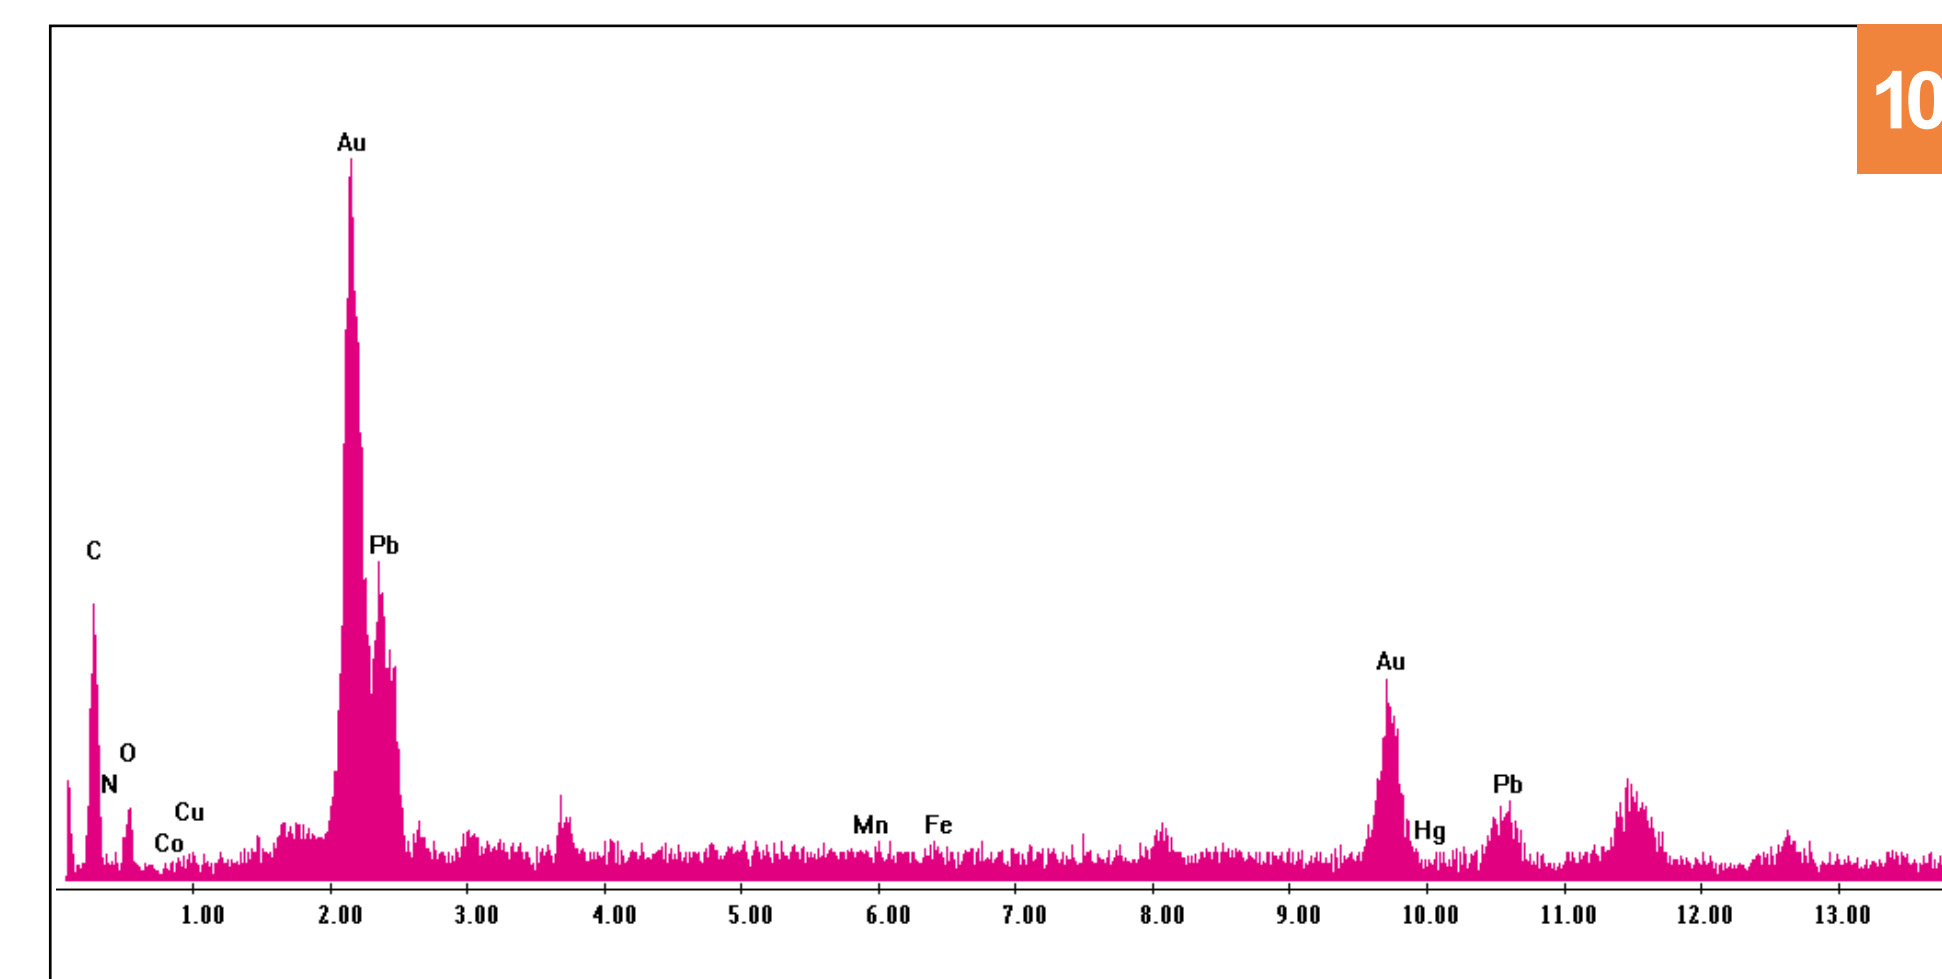
10

(10) SEM/EDX result.

Scanning electron microscopy with energy dispersive x-ray spectroscopy (SEM/EDX) was used to identify whether gold paint or gold leaf had been used on some areas. With the gold element detected as evidence by SEM/EDX, gold gilding was applied at the final retouching stage. Subsequently, the doors (except those areas with the carved door gods) were coated with tung oil, a traditional protective coating commonly used on Chinese architectural elements as a water and pest repellent.

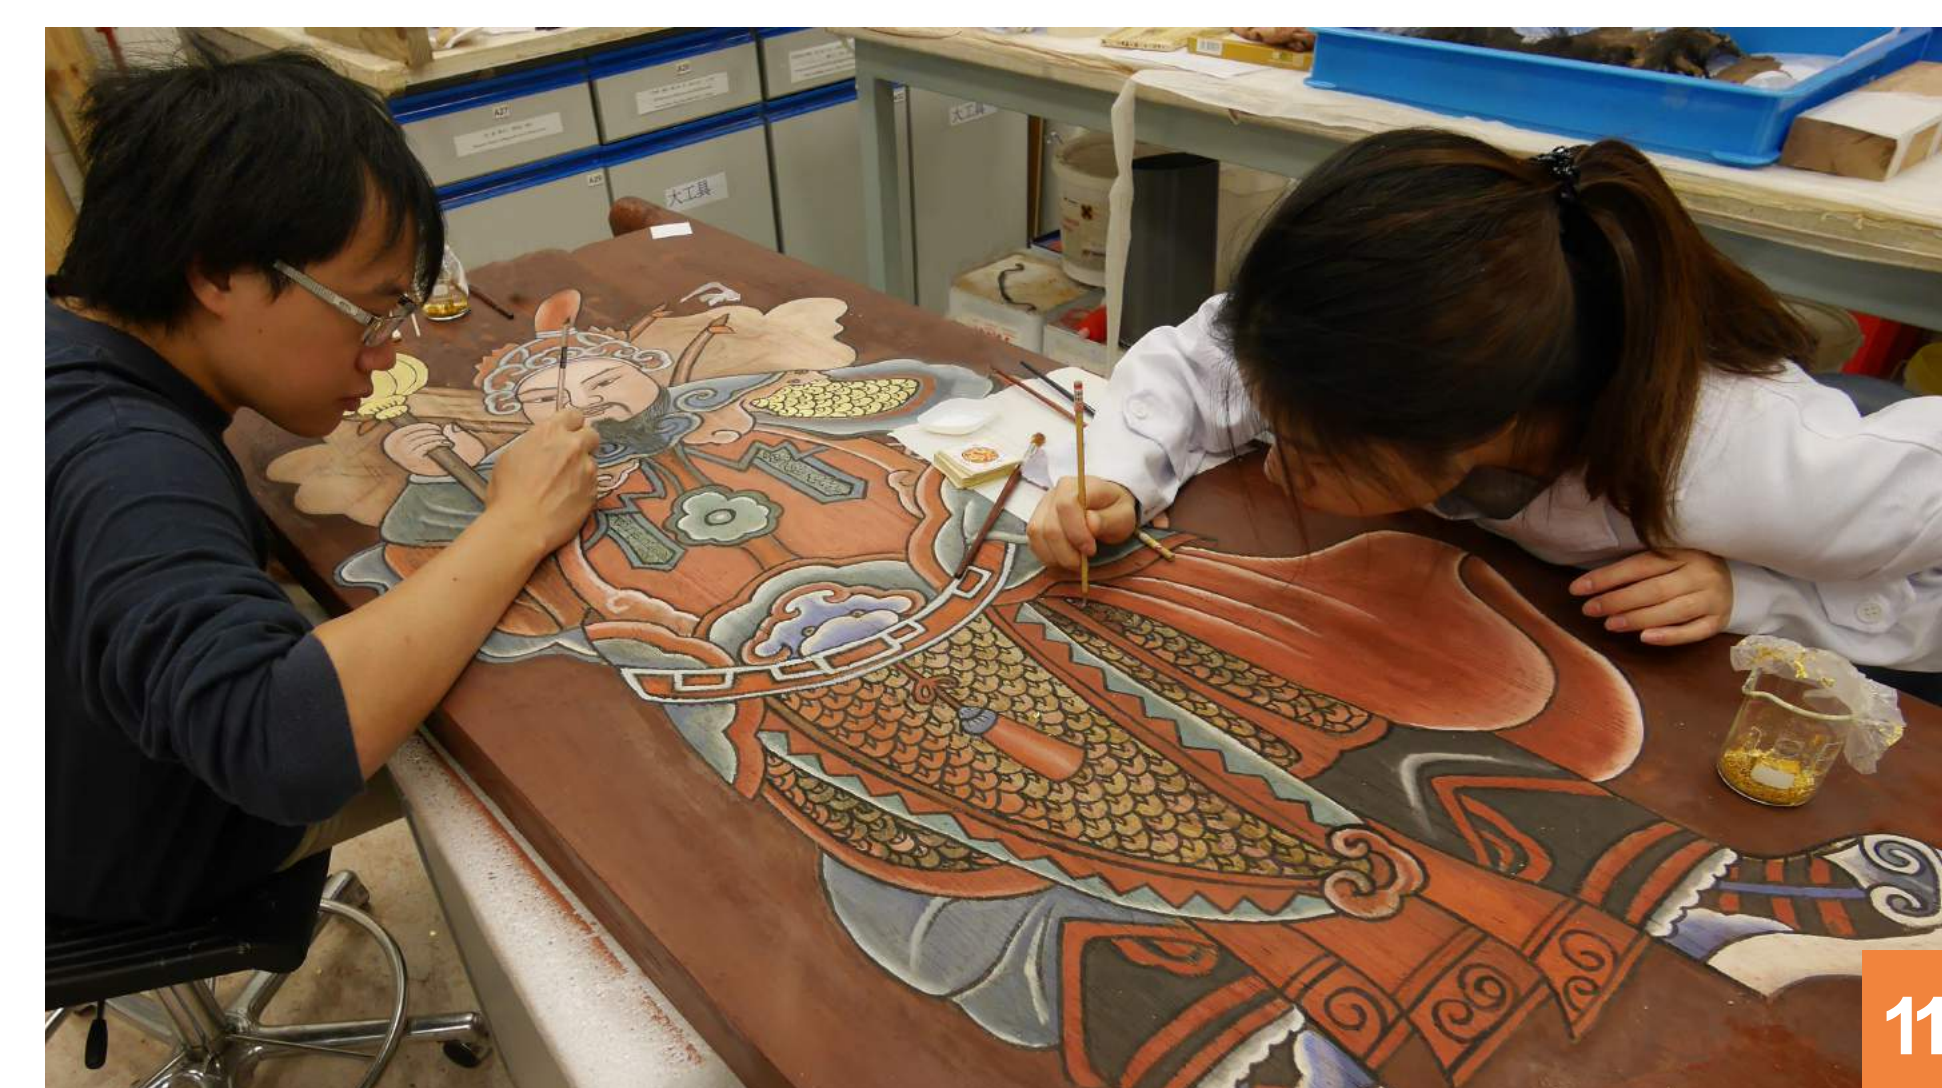
11

(11) Gold gilding and retouching.

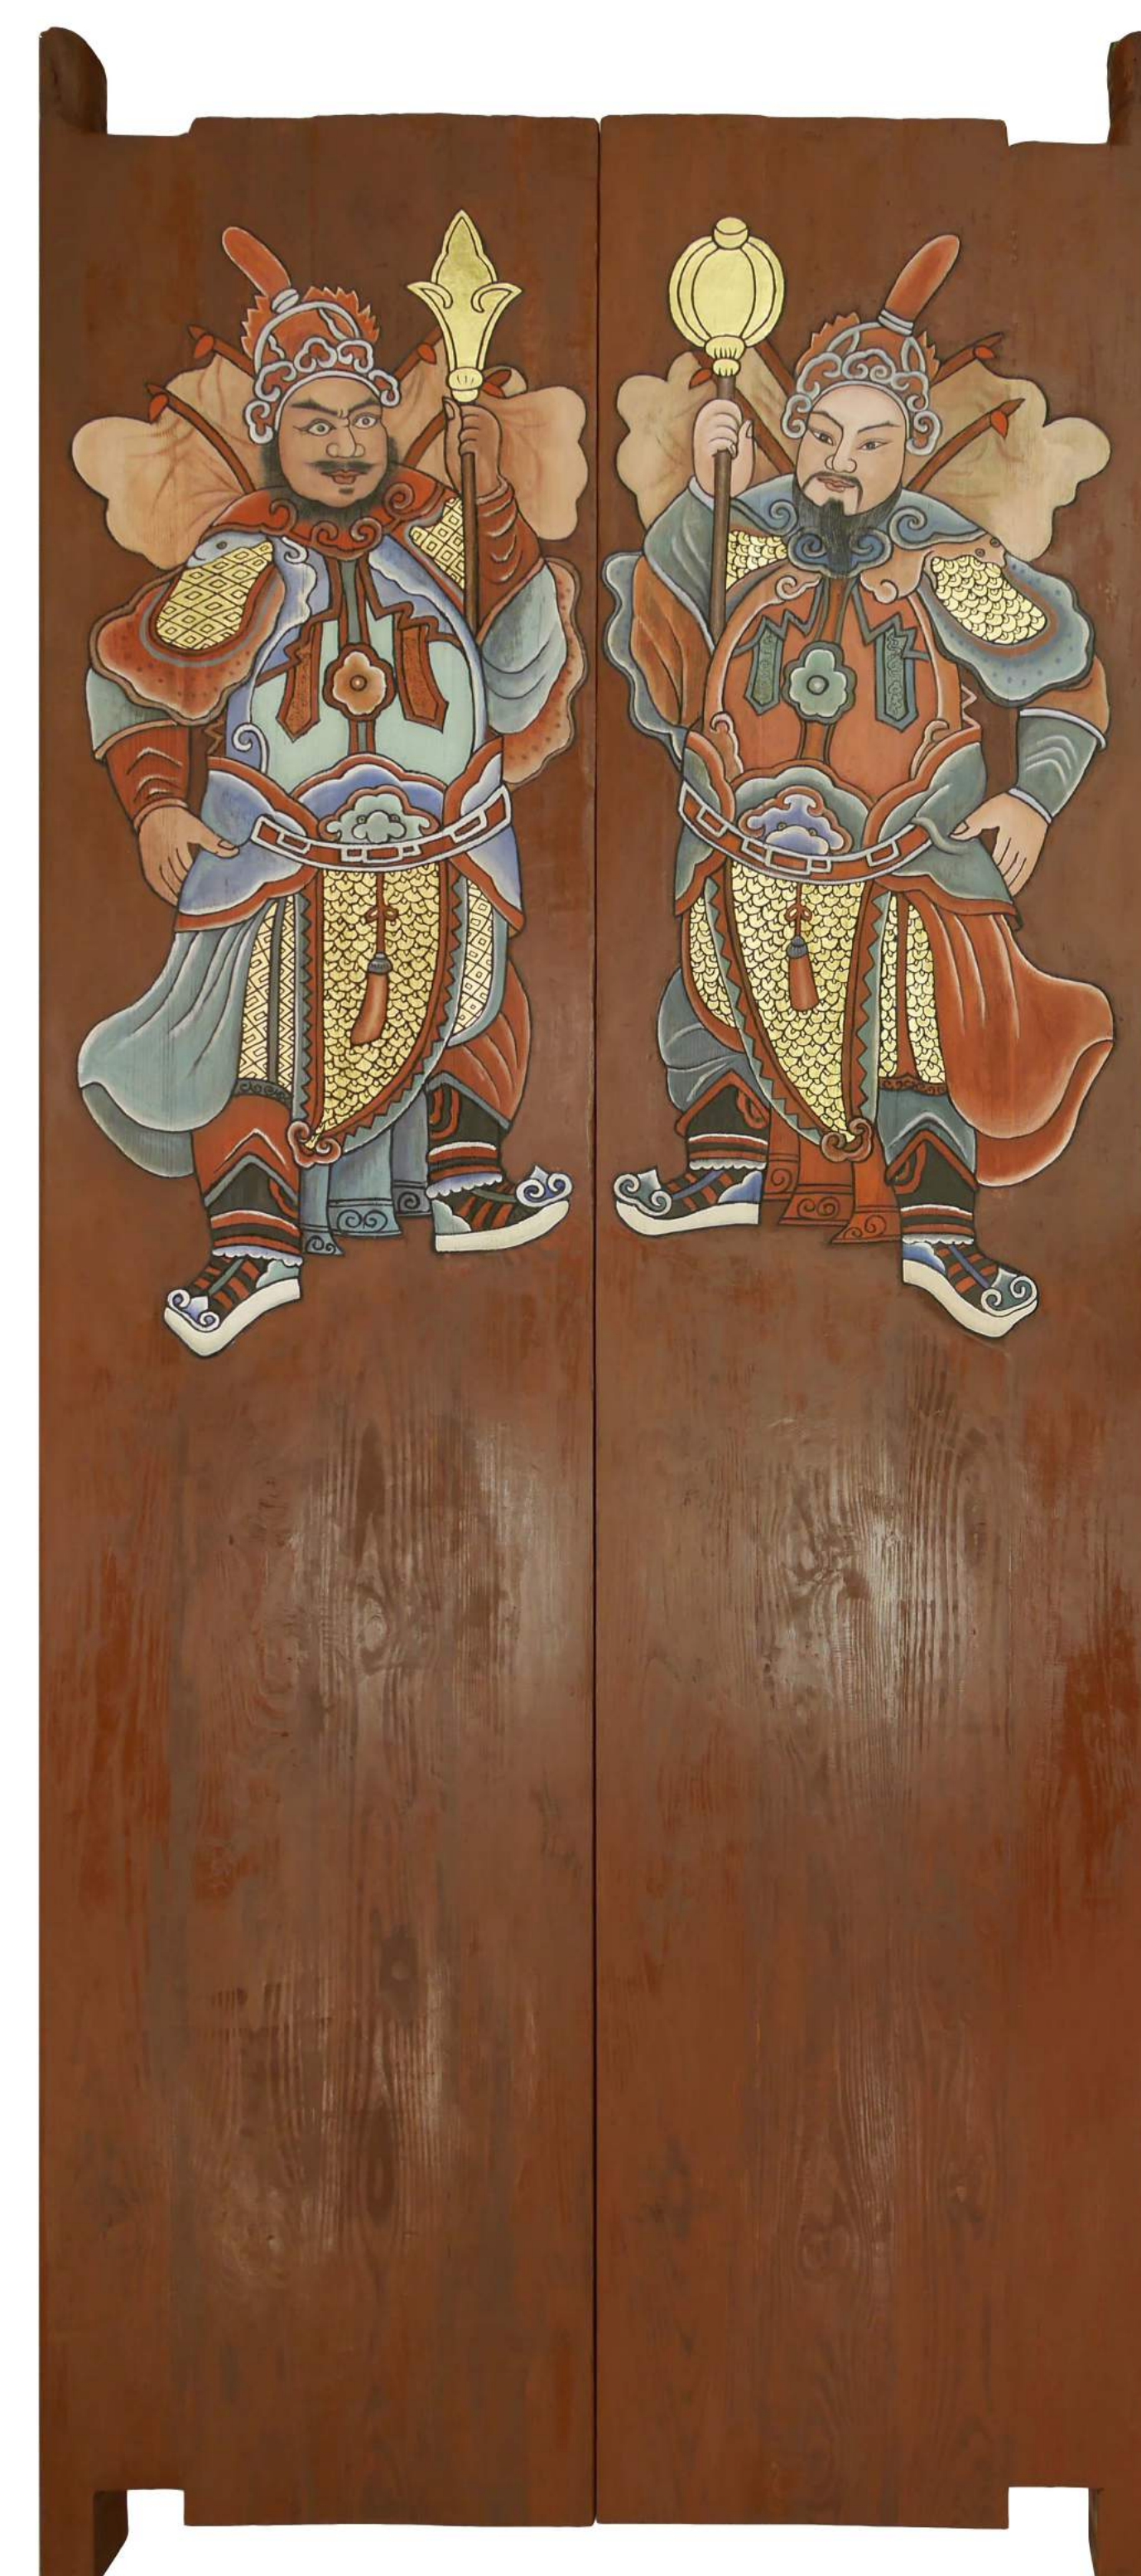
12

(12) Doors after restoration.
